AMORY CURRENT LAKE BIOASSESSMENT
AUGUST 2014

On **August 19th, 2014**, Seminole County Lake Management Program staff (Thomas Calhoun, Gloria Eby, and Marianne Pluchino) surveyed the aquatic plants in Lake Amory and conducted a Lake Vegetation Index (LVI) bioassessment.

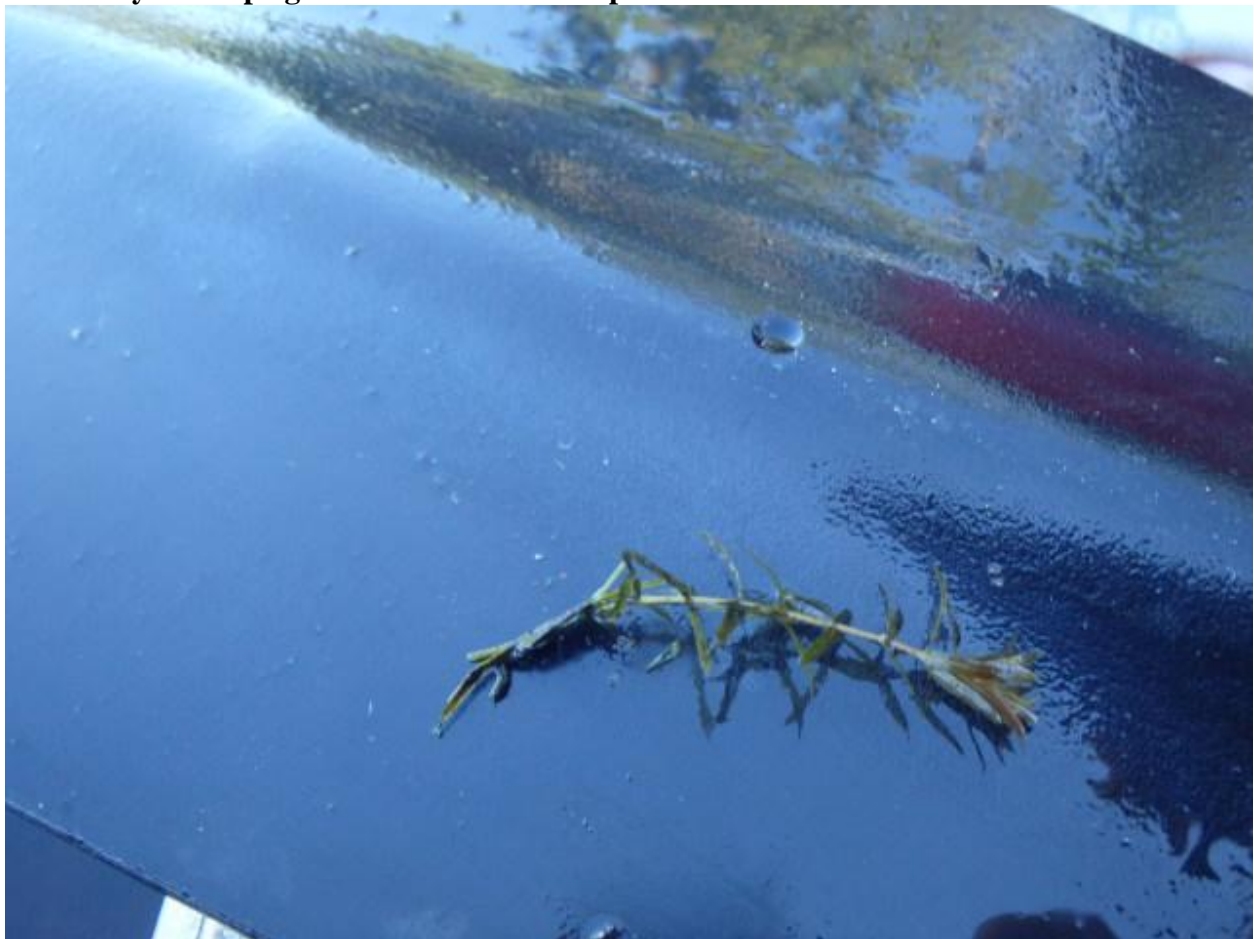
All areas of the lake were accessible. In **Lake Proper** area, blue green algae was observed for the second consecutive month. Hydrilla sprigs were found around **Bird Island** and the **Lake Proper** areas. The current amount of hydrilla requires no treatment action at this time. Hydrilla will be closely monitored over the next few months.

Photo: Hydrilla sprig found in the Lake Proper area.

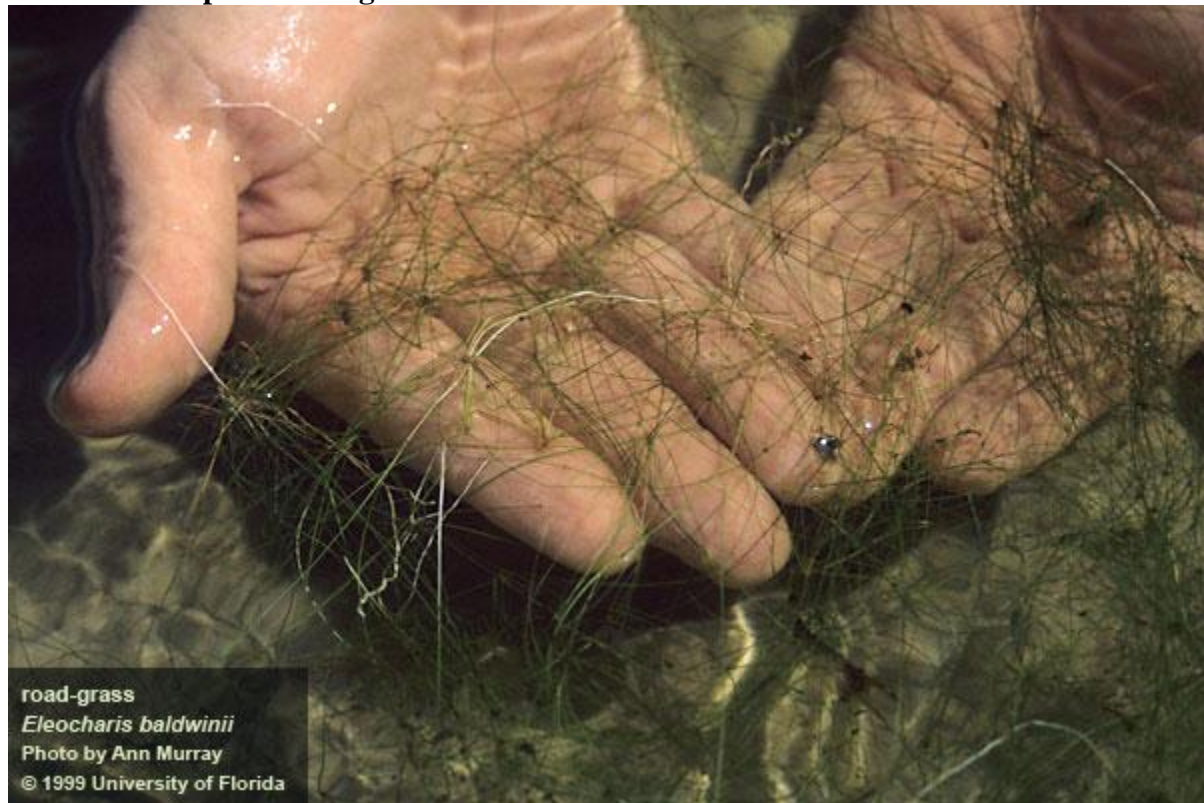
Cactus Canal and **Outfall Canal** were found to be in good condition. Submersed aquatic vegetation (SAV) observed in the cove included roadgrass and bladderwort. Invasive emergent vegetation included: alligatorweed, elephant ear, dog fennel, and torpedo grass.

Photos: Example of road grass.

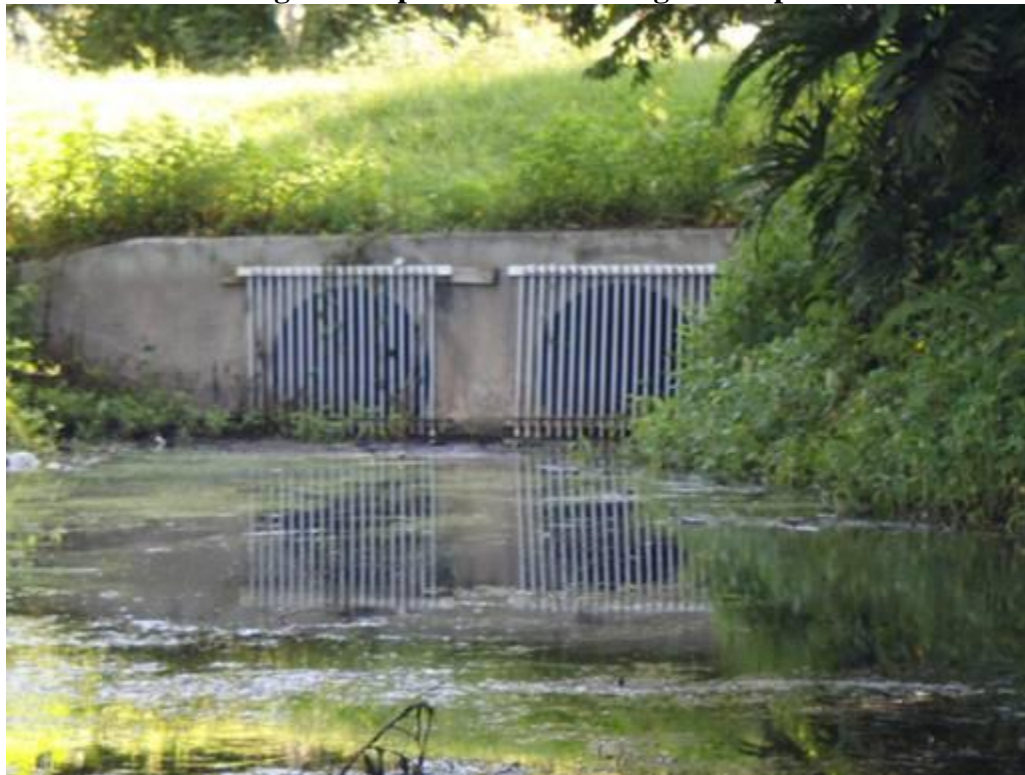
Photo: Outfall and grass carp barrier found in good shape.

The secchi reading (water clarity) at the time of inspection was 4.2 feet in a total depth of 11.5 feet. No triploid (sterile) grass carp fish were observed during the inspection. The grass carp barrier was found in good condition. Water elevation at the time of inspection was 39.9 feet above sea level.

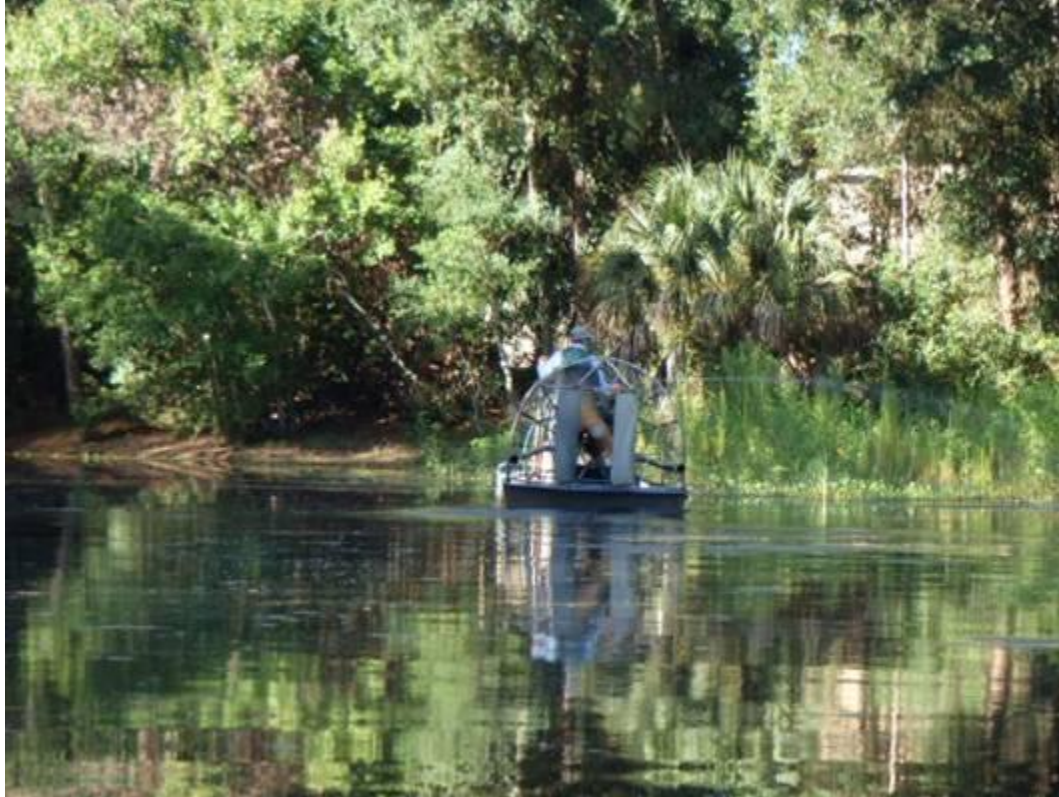
In the **Bird Island** area, small sprigs of hydrilla were found. At this time, no action is required. Native vegetation such as duck potato, pickerelweed, native sedges, smartweed, roadgrass, spike rush, and bulrush had expanded in this area. The treatment for invasives has done very well in this area.

Photo: Herbicide contractor treating exotics in the bird island area.

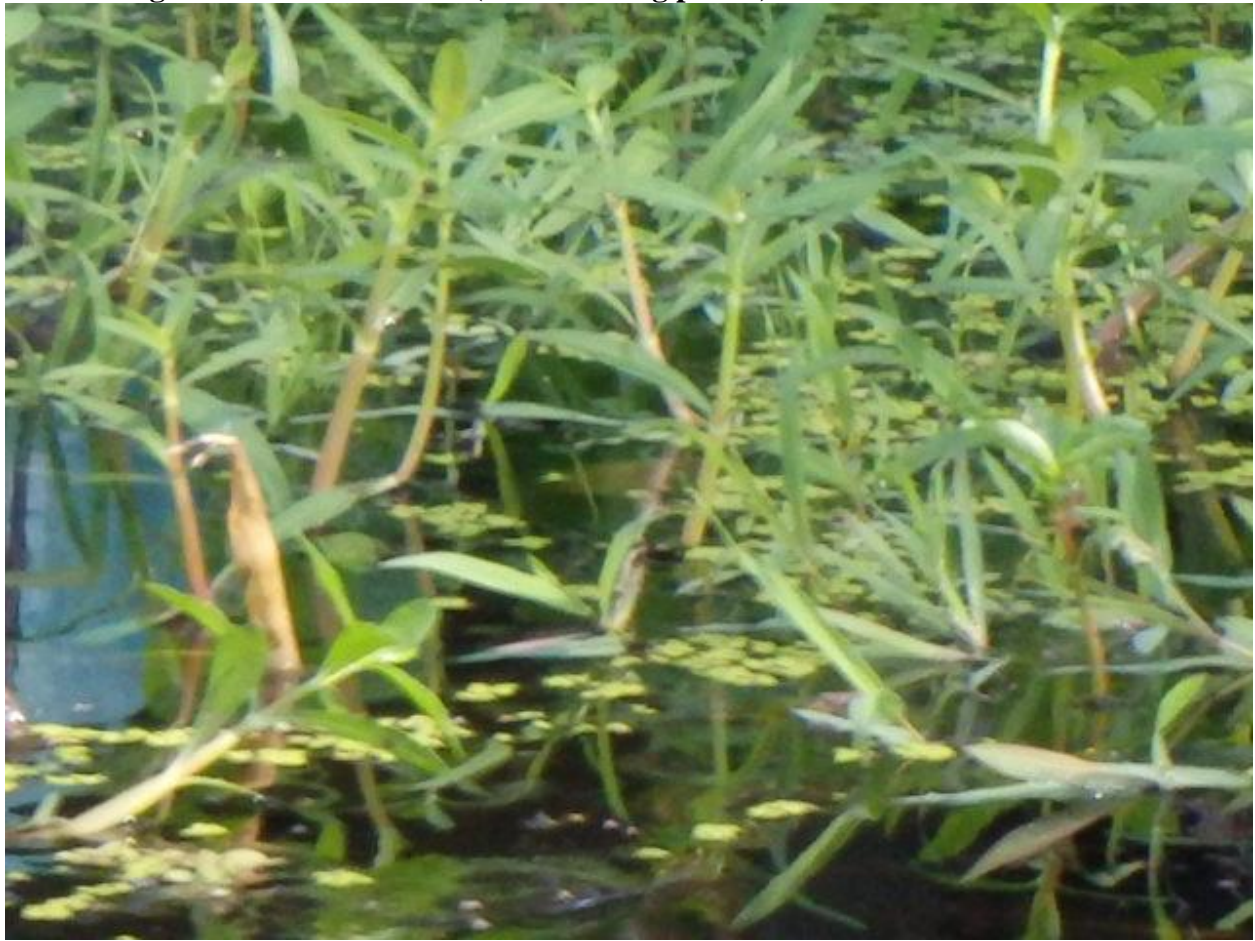
The Cove was found to be in great shape again! Native emergent vegetation was expanding very well in this area. Previously planted canna, pickerelweed, and duck potato have established and are growing well. Invasive torpedo grass and alligatorweed were targeted in this area for herbicide treatment.

Photo: Alligatorweed and salvinia (small floating plants).

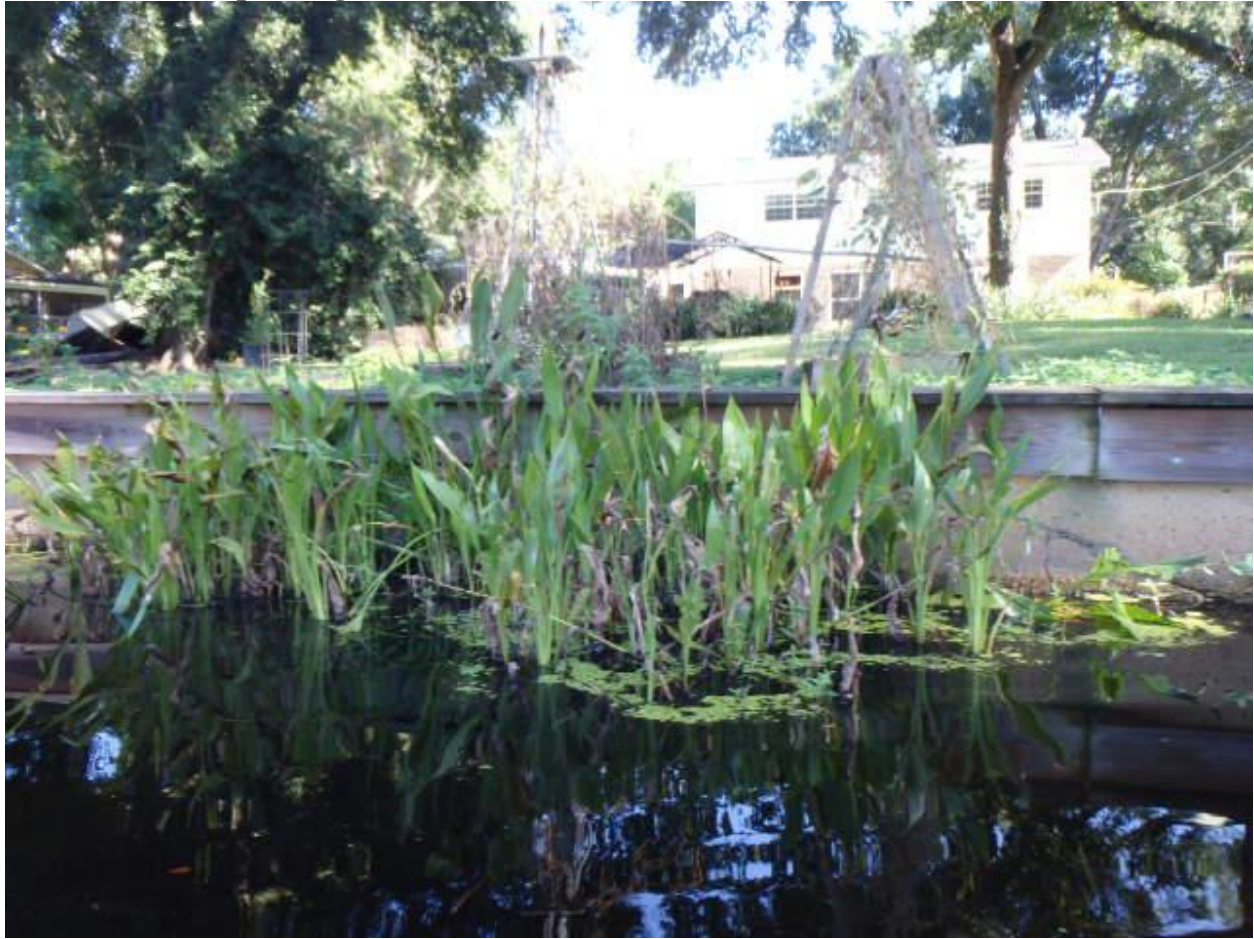
Photo: Canna expanding in The Cove.

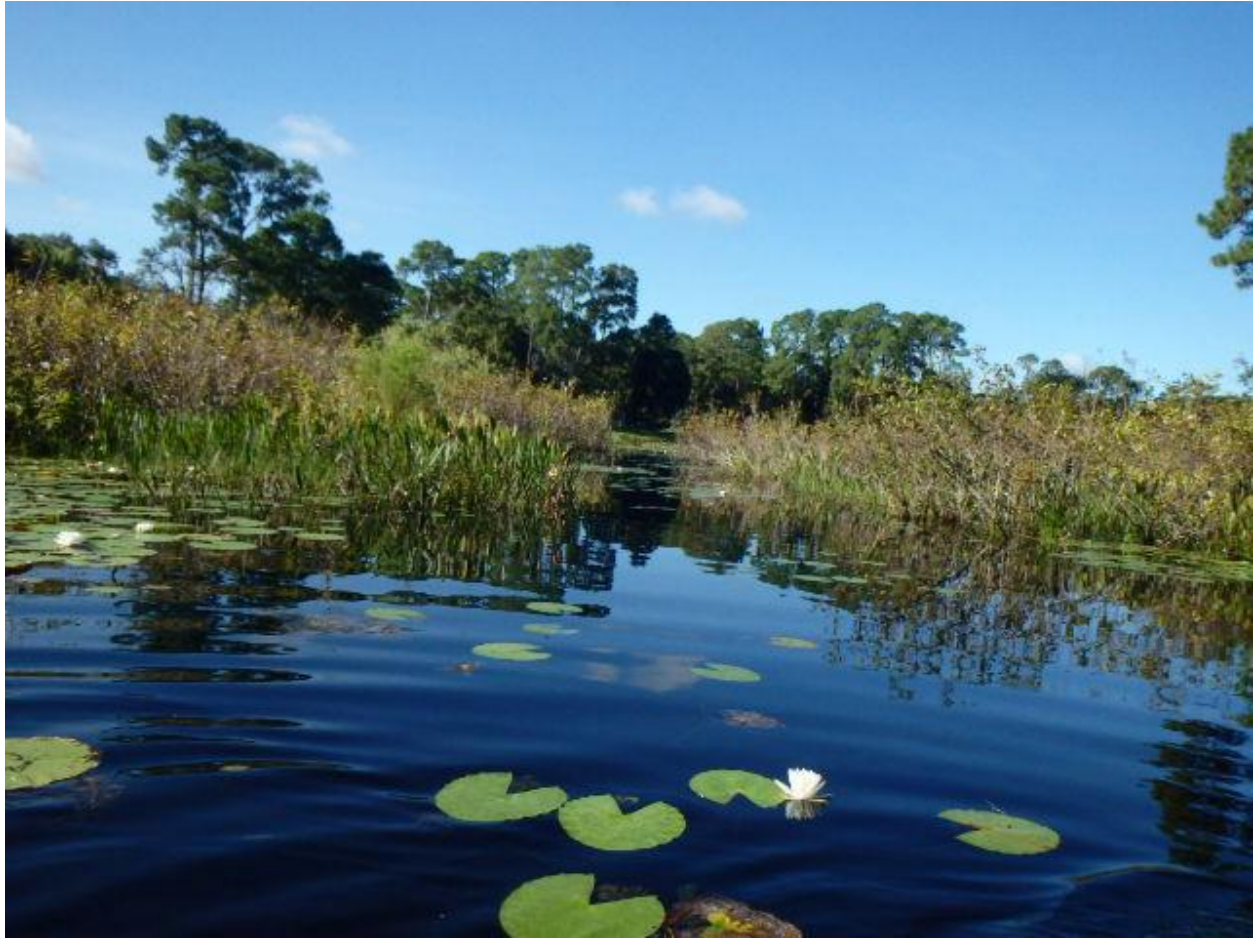
The **Lake Proper** area was found to be in good condition as well. The access corridors were open and accessible. Alligatorweed and torpedo grass were targeted during the treatment.

Photo: Accesses corridor.
